AMUSEMENTS PARKS: CASE STUDIES & SAFETY AUDITS

Dnyanesh M. Divekar
Wilson Rodrigues
Mec Elec Industrial Services

Roller Coaster - Vertical Axle Pin Failure Investigation

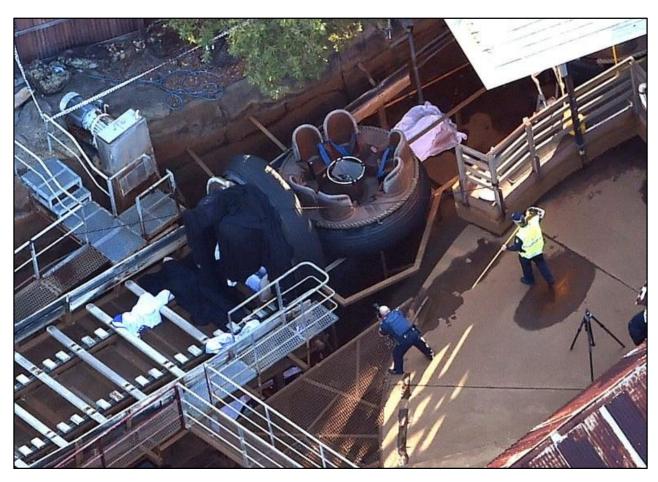
Dreamworld, Australia, Thunder River Rapids, Oct 2016:
 4 guests killed when a raft flipped over. Ride permanently closed

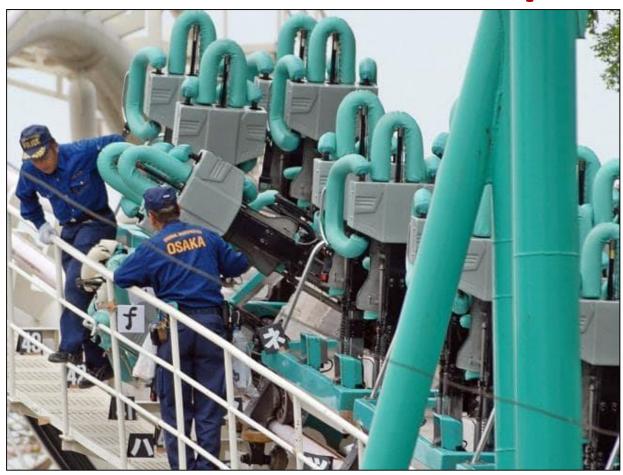
Expoland, Fujin Raijin II Roller Coaster, Osaka Japan, May 2007:
 Broken wheel axle caused derailment and one guest died from head injuries.

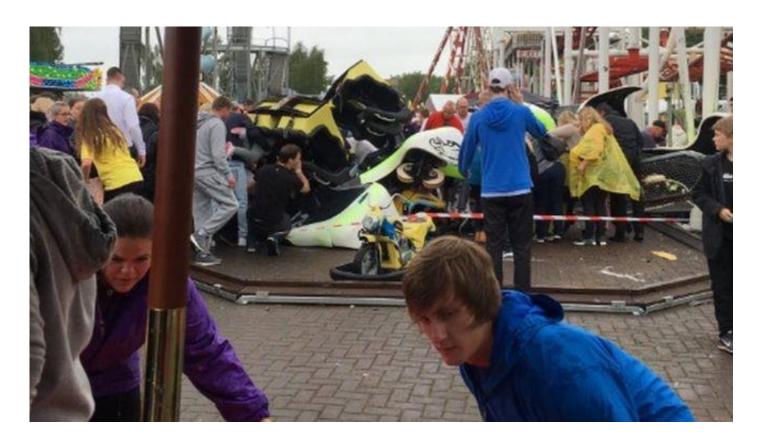
Tsunami Roller Coaster, M&D's, Scotland, June 2016:
 5 gondolas of the inverted roller coaster crashed 30 ft. 9 injured.
 Weld repairs on axle found faulty. Welding metal & axle metal incompatible. Ride closed permanently

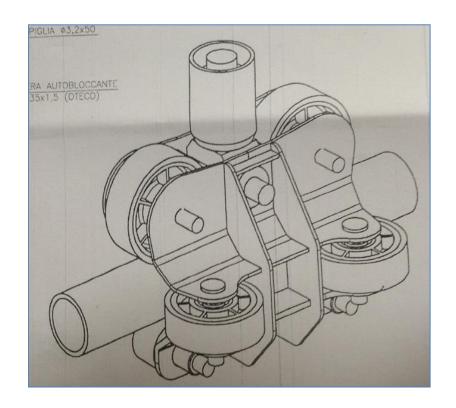
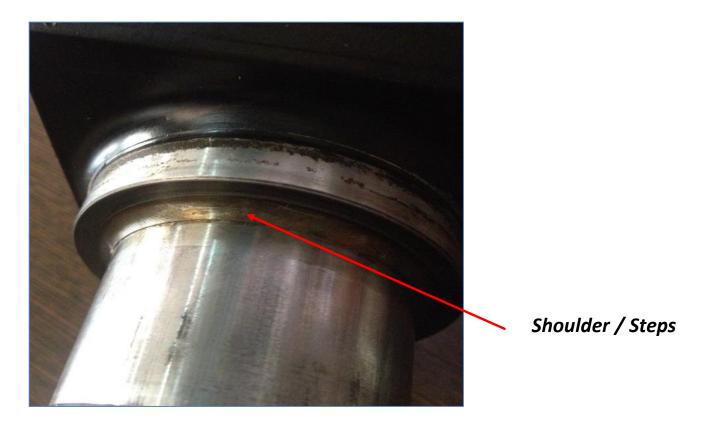
- Vertical axle is critical part of a roller coaster as it connects the car to the wheel equaliser assembly
- It is a forged part with two taper bearings mounted on induction hardened surface
- Axle is subjected to shear load in the linear and perpendicular direction and some fatigue and bending loads

Axle pin had a few steps / shoulders that could have acted as stress concentrators if not properly rounded

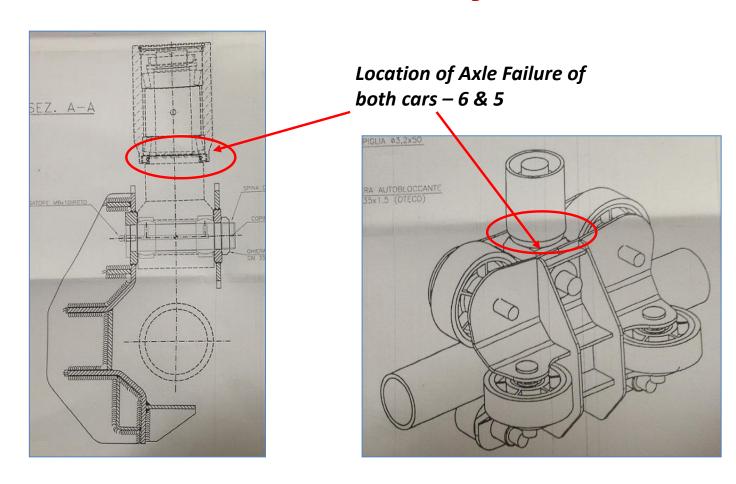
Location of plane along which axle failure occurred in car number 6th and 5th car

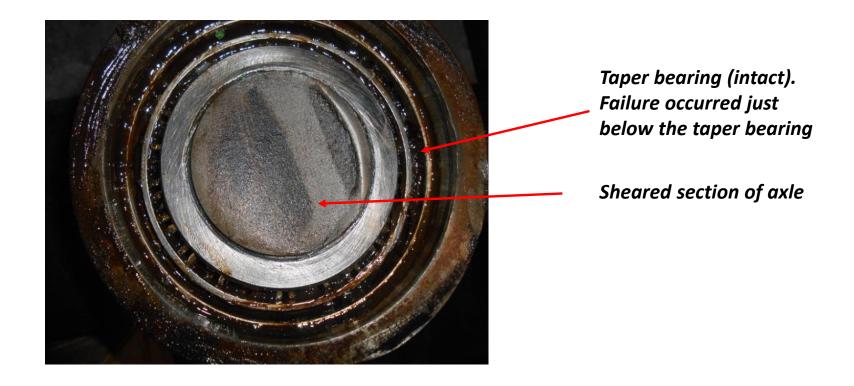
The shaft snapped exactly at the location of the shoulder / step

- Location of failure of the axle was inside its assembly housing and was not readily accessible either for visual inspection or for NDT
- The ride had completed only 20% of its expected one year design run
- The manufacturer's recommended inspection of the vertical shaft by stripping open the car was still a few months away
- NDT of the undamaged vertical shaft in Car number 4 was conducted
 - UFD Ultrasonic Flaw Detection
 - MPI Magnetic Particle Inspection
 - LPT Liquid Penetrant Testing

- It was concluded that the failed and cracked vertical axles were
 - a product of either inadequate design considerations
 - or improper inspections and process control at the manufacturing stage
 - or both.
- The axles were not due for NDT inspection (possible only after a complete strip down of the cars) for at least a few more months. The operations too were only about 20% of the expected running time for a year of service.
- The O&M personnel were entirely compliant with inspection guidelines and schedule of the manufacturer

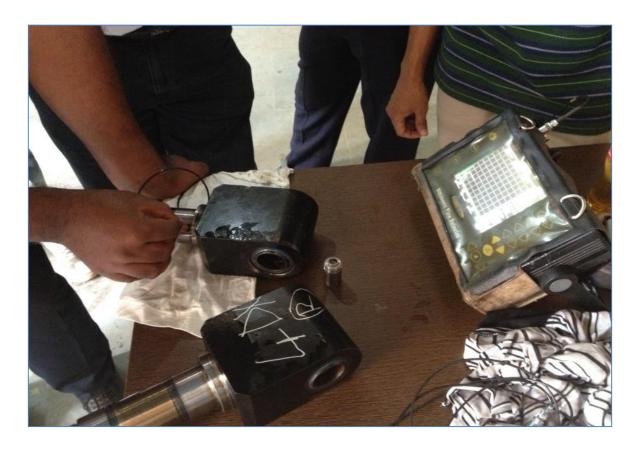
UFD carried out to identify subsurface cracks, voids, porosities

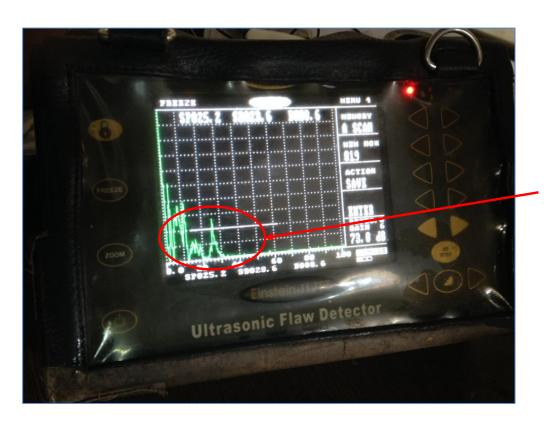
Relevant indication near axle shoulder

UFD indicated surface discontinuities

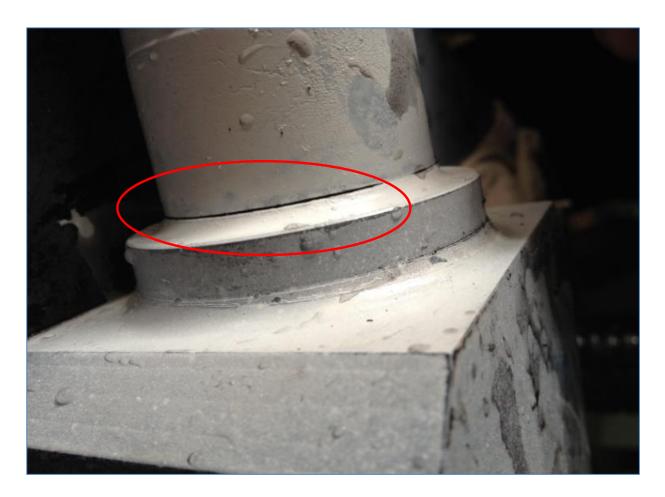
MPI is used to detect surface and subsurface cracks

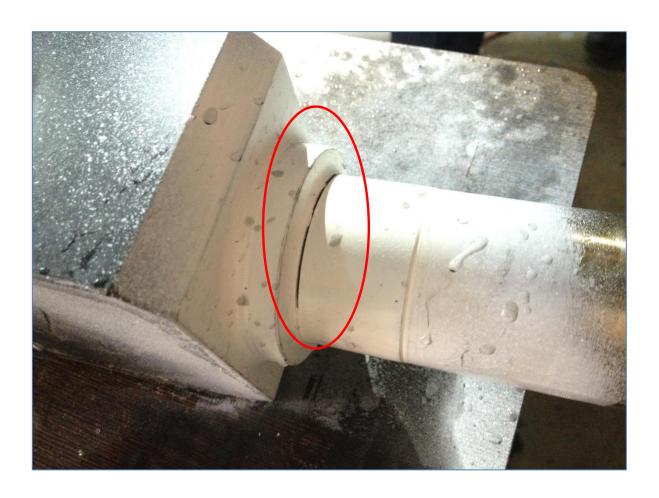
MPI displayed a sharp indication near the shoulder

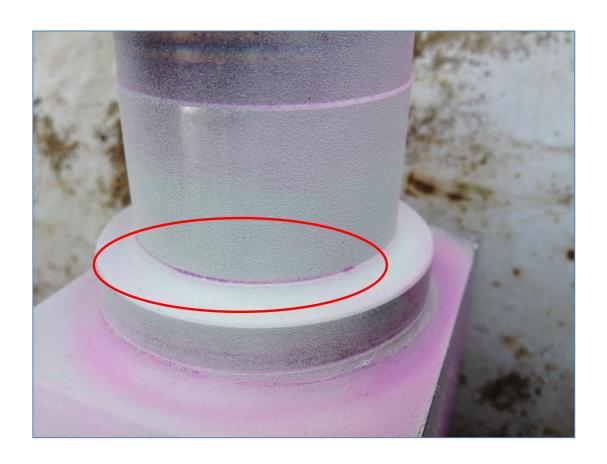
Final confirmation with LPT to detect surface cracks
